Michigan SHPO Architectural Properties Identification Form

Street Address	33 Miller Road				
City/Township, State, Zip Code	Clarkston, Michigan 48346				
County	Oakland				
Assessor's Parcel #	14-08-20-181-002				
Latitude/Longitude (to the 6 th decimal point)	Lat: 42.740420	Long: -83.421900			
Ownership	Private <input checked="" type="checkbox"/>	Public-Local <input type="checkbox"/>	Public-State <input type="checkbox"/>	Public-Federal <input type="checkbox"/>	Multiple <input type="checkbox"/>

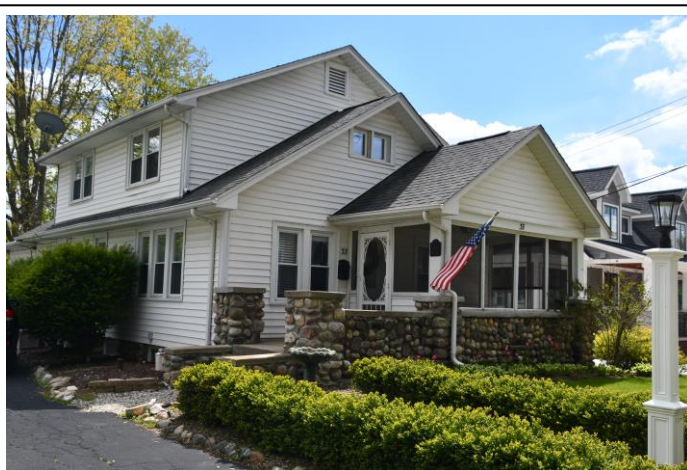
Construction Date	c 1928
Architectural Style	Craftsman/Bungalow
Building Form	Rectangular
Roof Form	Dual Front Gables
Roof Materials	Asphalt Shingles
Exterior Wall Materials	Wood Siding
Foundation Materials	Fieldstone
Window Materials	Wood ?
Window Type	Double Hung
Outbuildings	Yes <input checked="" type="checkbox"/> No <input type="checkbox"/>
Number/Type:	1/Garage

This dual front gabled style house sits on the south side of Miller Road. The original one and one-half story house with a front gable has a front gable addition making it two full stories. The north (front) elevation of the original house with a moderately pitched roof has a pair of almost square single pane windows, lightly off center near the gable peak. On this north elevation, west half of the house is a screened porch with a steeply pitched gable roof. There is a large louvered vent in the peak of the addition top gable.

The porch has four screened windows on the north elevation, two screened windows on the west elevation, and one screened window and an entrance on the east elevation. To the east of the front porch on the first story of the house is a pair of tall narrow one over one double hung windows. The fieldstone foundation is a dominant feature of the north elevation.

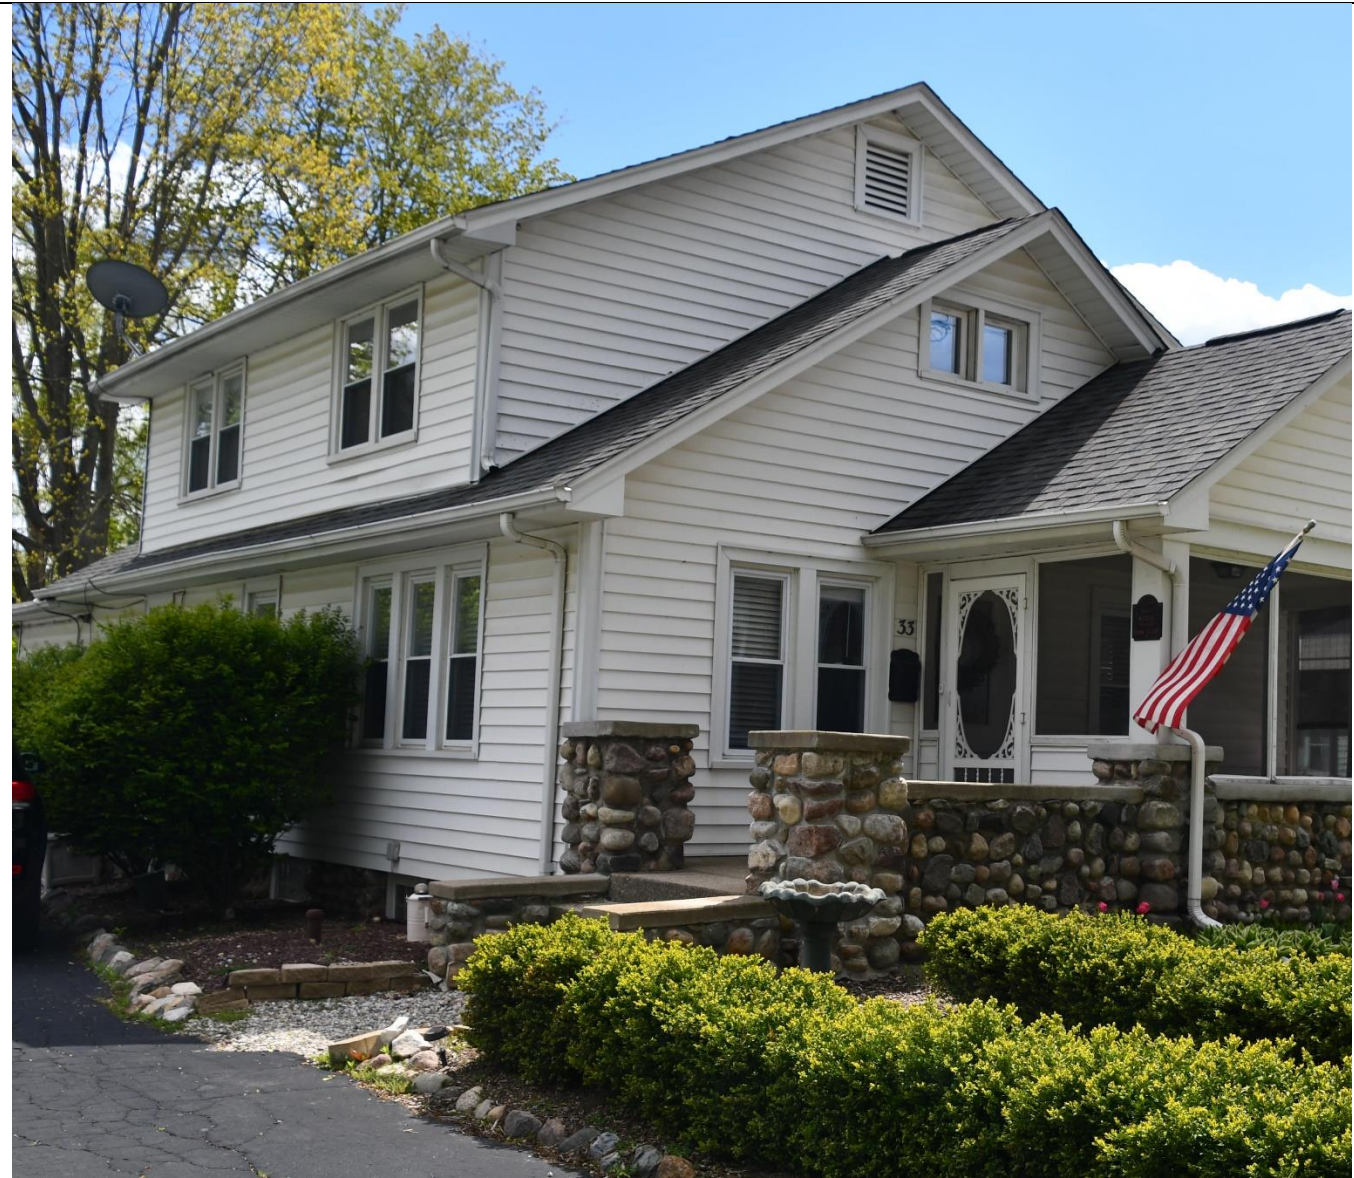
(east elevation)

The east elevation of the porch on the north has a cement landing along the north elevation of the house with two prominent fieldstone pillars on each side of the steps leading to the driveway. The steps have a fieldstone wall on each side. On the north side, the wall continues to form the porch foundation. The second story of the east elevation has two pairs of one over one double hung windows (one at each end). The first floor has a grouping of three slender one over one double hung windows near the north end; a smaller one over one double hung window toward the middle of the east elevation; a one over one double hung window near the south end of the east elevation. On the south elevation is an addition with an entrance to the driveway on the east elevation.

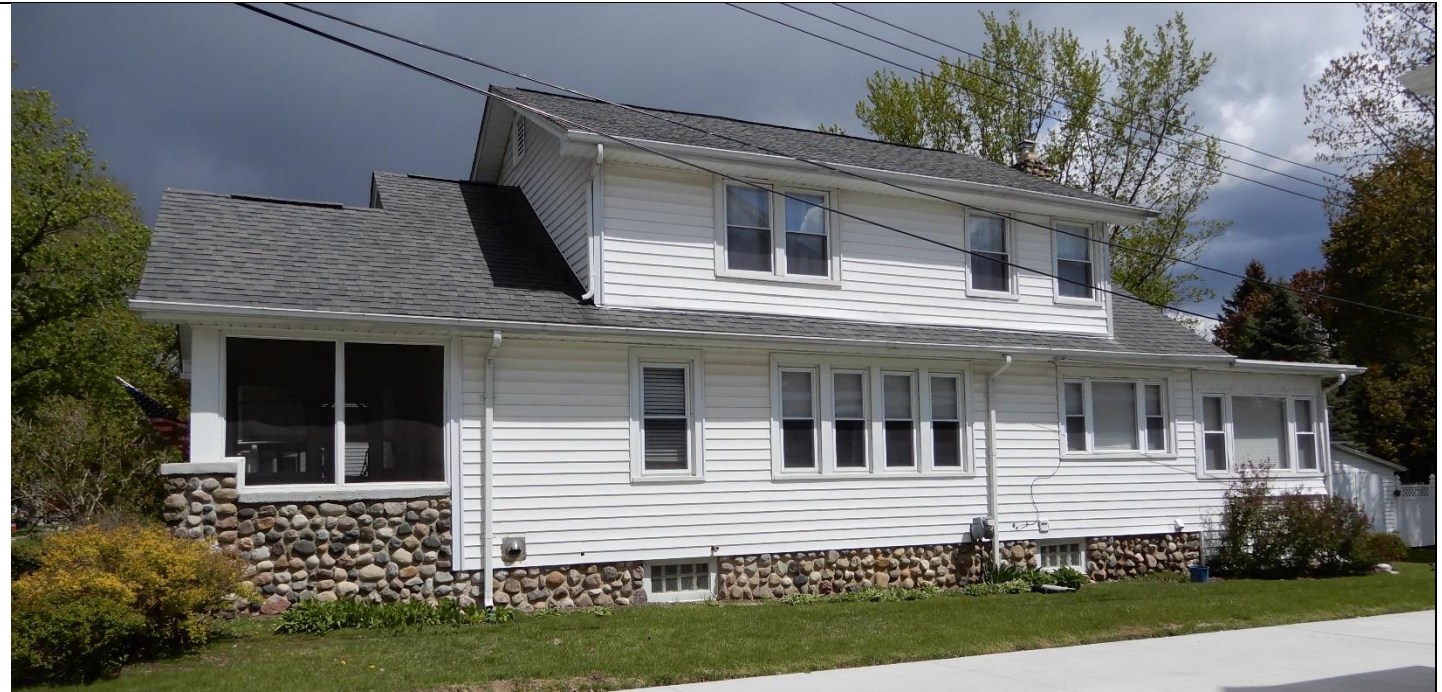
(west elevation)

The west elevation second level has a pair of one over one double hung windows toward the north end and then two additional one over one double hung windows toward the south. The first floor has a one over one double hung window toward the north and then a grouping of four single pane double hung windows in the middle of the west elevation. At the south end is a square picture window with a narrow double hung window on each side. The addition on the west elevation has a larger square picture window with a double hung window on each side. The fieldstone foundation is prominent along the west elevation with two small horizontal windows with four-by-four panes each.

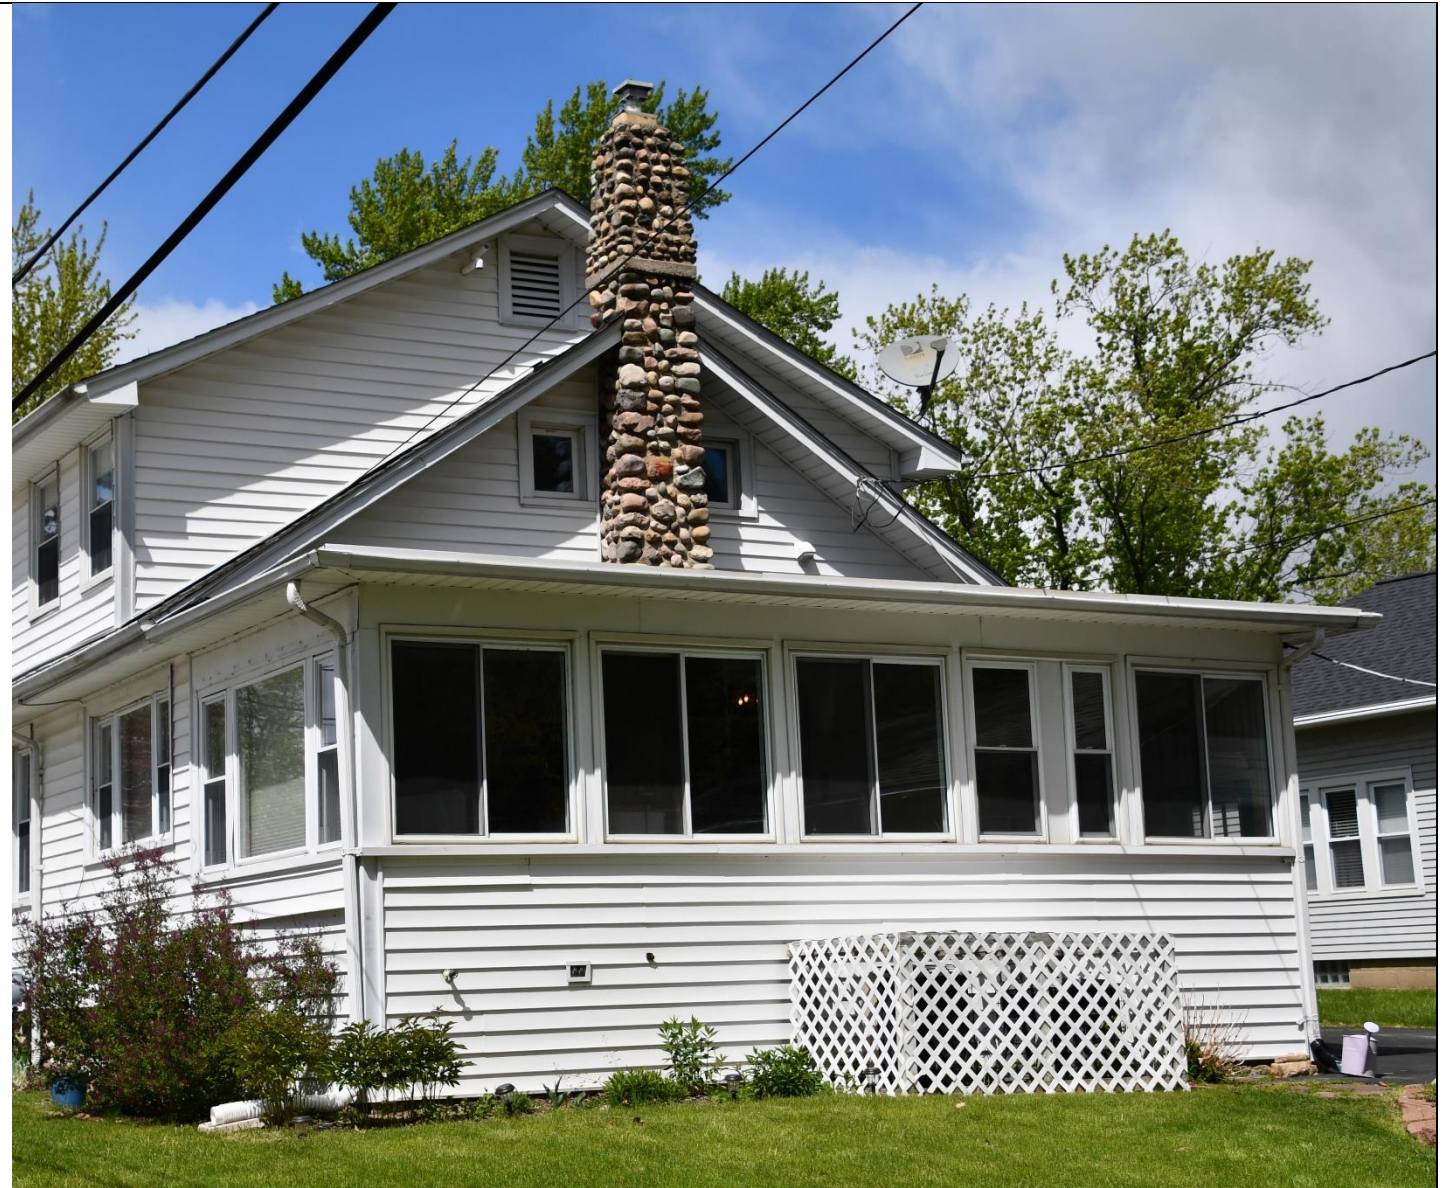
(south elevation)

The south elevation second story has a large louvered vent in the peak. The gable roof directly below (the addition on the south elevation) has a prominent fieldstone chimney through the peak and extending above the roofline of the second floor with a small rectangular window on each side of the chimney within the gable. The remainder of the addition has a low-pitched roof with five pairs of screened windows. This addition is covered with siding (i.e. no visible fieldstone foundation).
